EVALUATION OF REDESIGNED XW18 MEMBRANE
AND ACCESSORIES

TECHNICAL REPORT S-73-3

Conducted by U. S. Army Engineer Waterways Experiment Station
Soils and Pavements Laboratory
Vicksburg, Mississippi

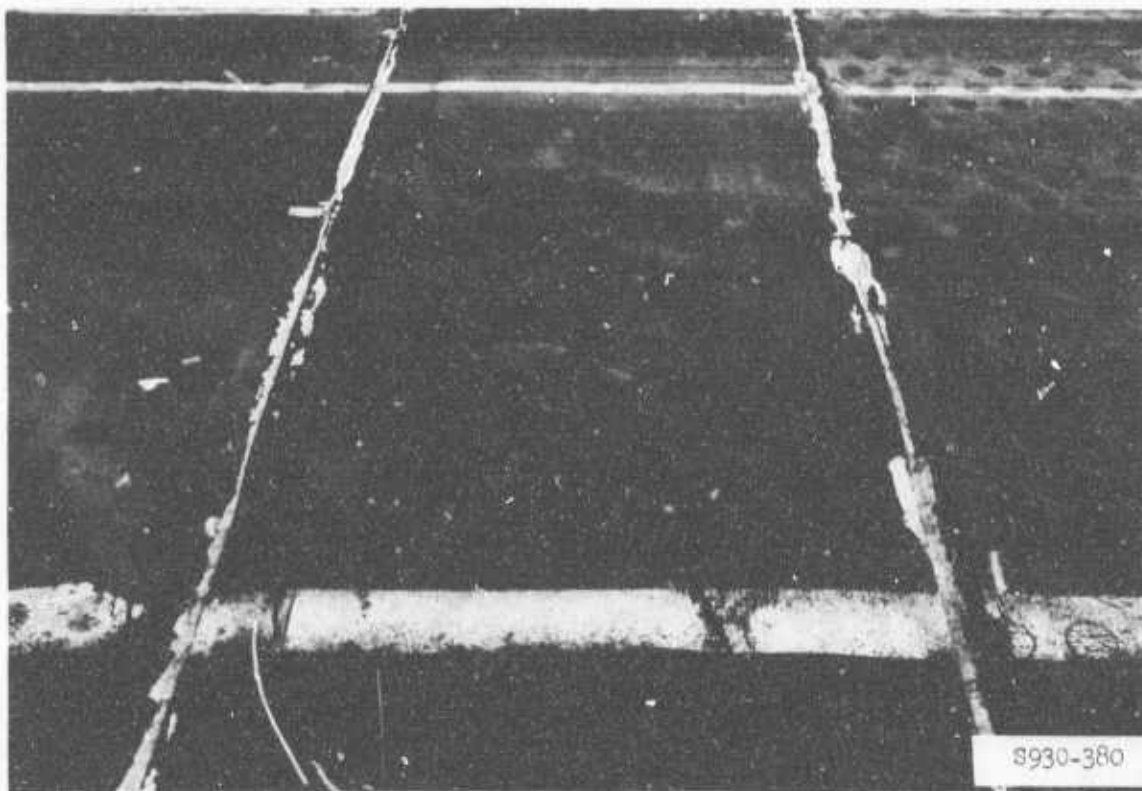
78. Photo 79 shows the general condition of the test section after 200 coverages. At this coverage level, there were no major occurrences, and the membrane showed little wear. Photo 80 shows the condition of the 3-ft-wide reinforcing strip on the joint between the two sheets. The sealant shown along the edges of the strip was wearing well and required no repair at this point. However, several of the 6-in.-wide factory fabrication joints that connected the runs of membrane were beginning to peel loose (photo 81). When the test wheel passed over a joint where a wrinkle resulting from slack in the surfacing was present, the wheel folded the wrinkle over, stressing the adhesive bond between the double layer of surfacing and causing the surfacing to peel loose. The peeled areas extended approximately 1 in. into the 6-in.-wide factory joints and were repaired by use of the MG-180 adhesive. Approximately 12 percent of the nonskid compound on sheet 1 and 5 percent of the nonskid material on sheet 2 had been removed by trafficking of the test vehicle at this coverage level (plate 19).

Photo 80. General condition of reinforcing strip and joint sealant of traffic test section 2 after 200 coverages

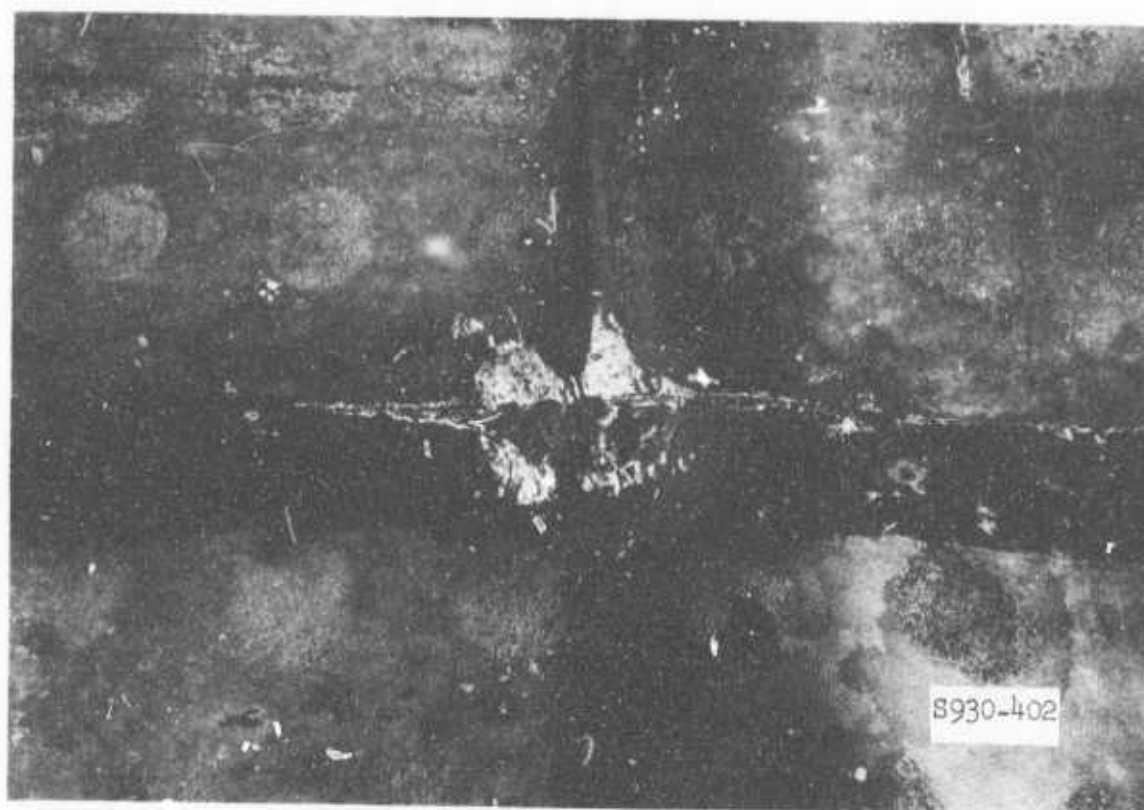
Photo 82. Use of 3M Weatherban sealant on peeling 6-in.-wide factory fabrication joint of test section 2

80. Further peeling of the 6-in.-wide factory fabrication joints required that steps be taken to prevent water infiltration through the joints to the subgrade. It was found that the dry-weather adhesive did not have adequate peel strength to effectively seal the wrinkles in the joints. However, a watertight seal was effected by use of the Weatherban sealant. The sealant was applied by inserting the plastic spout of the sealant cartridge into the peeled area of the joint and completely filling the void with sealant. Then pressure was exerted on the face of the membrane to fill the void left by the spout and provide a seal on the outside of the joint. Photo 82 shows a joint sealed using this procedure.

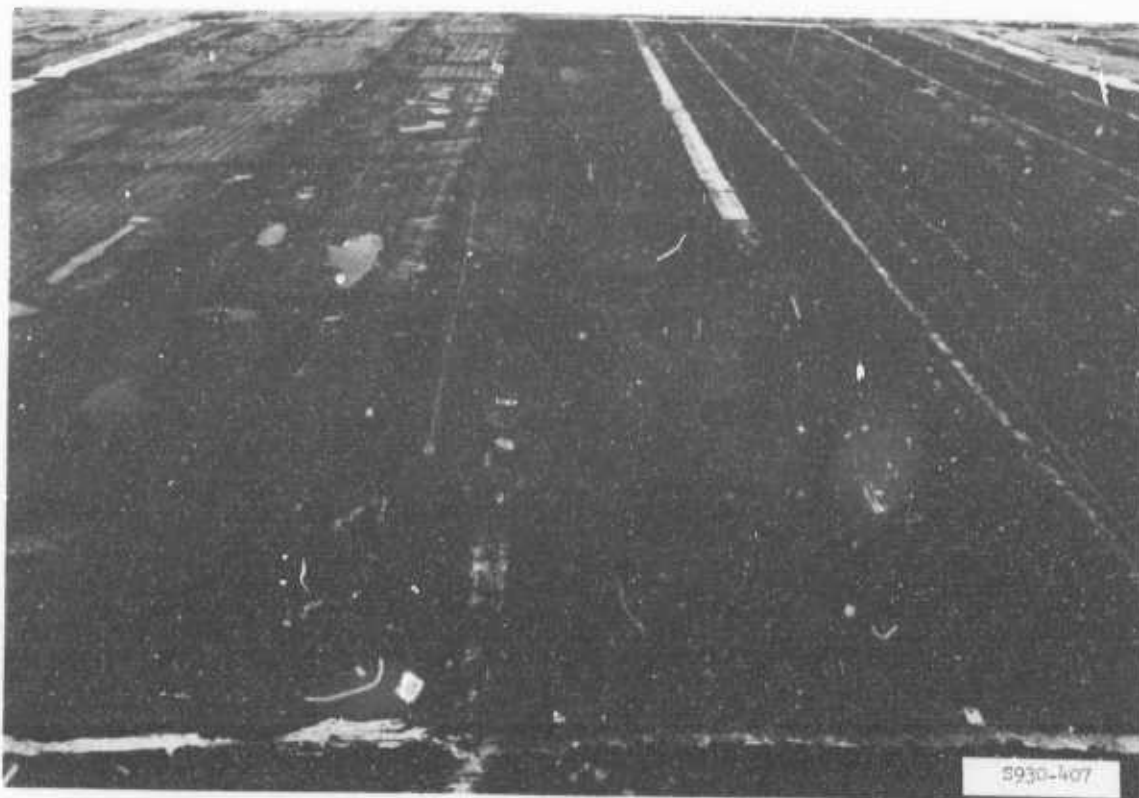
Photo 83. 54-in.-wide run of material of sheet 2 of test section 2
recoated with nonskid compound

81. An inspection of the nonskid pattern remaining after 600 coverages revealed that sheet 1 had lost approximately 38 percent of its nonskid pattern and sheet 2 had lost approximately 27 percent (plate 19). On one of the 54-in.-wide runs of material on sheet 2, the nonskid compound had been removed completely by the test vehicle. On this run, the nonskid had not bonded to the surfacing properly during factory application. This lack of bond was probably due to contamination of the surface of the run of material prior to application of the nonskid or due to improper curing of the neoprene coating. The run of material was recoated with nonskid to determine if the nonskid would adhere to the surfacing well enough to withstand trafficking. The run was cleaned thoroughly with solvent, and then nonskid compound was applied to the run in a solid coating with long-handled paint rollers. A general view of the run of material after reapplication of nonskid is shown in photo 83.

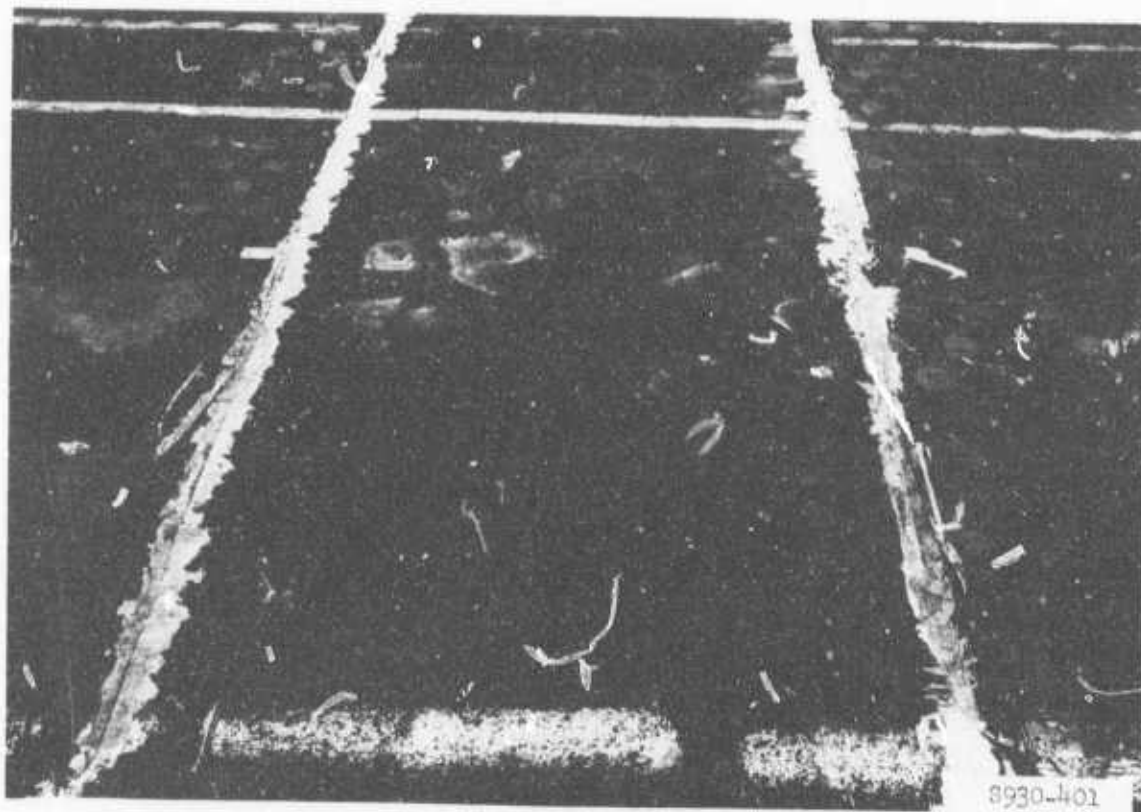
82. The 3-ft-wide cover strip on the joint between the two sheets was in good condition (photo 84). Only minor repair had been required

Photo 84. General condition of 3-ft-wide reinforcing strip after
600 coverages on test section 2

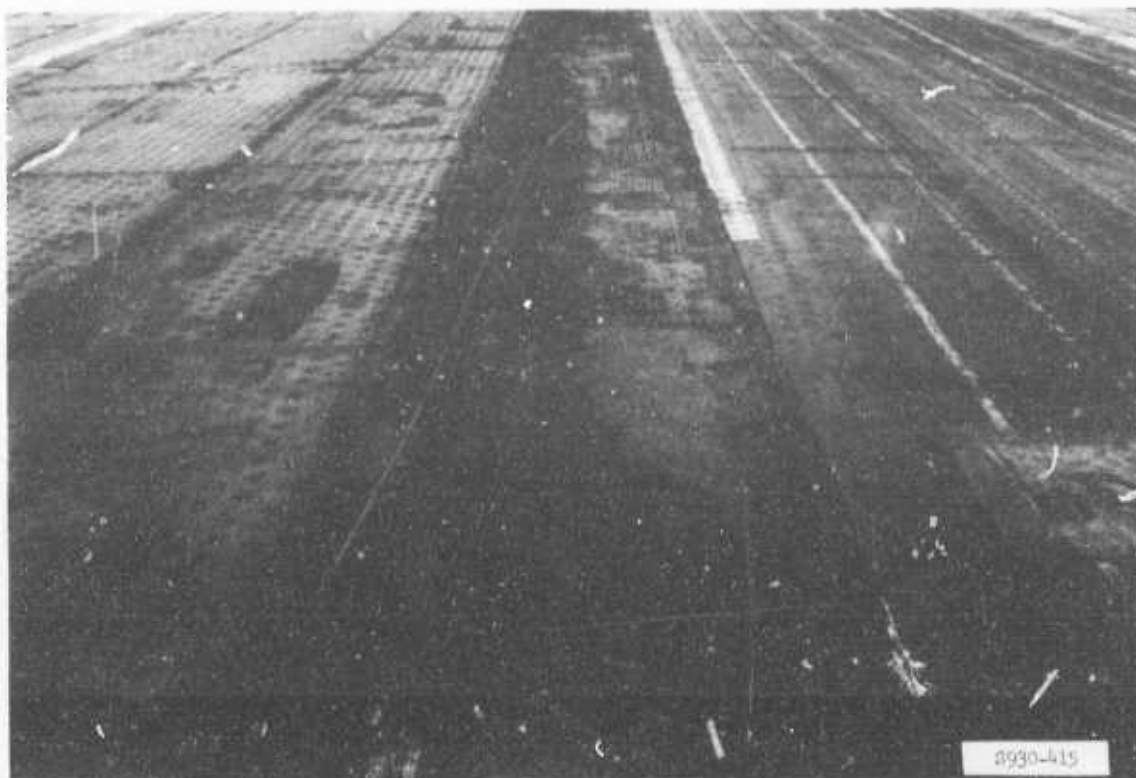
83. The general conditions of sheets 1 and 2 after 800 coverages of the load wheel are shown in photos 85 and 86, respectively. No appreciable deterioration of the membrane surfacing or subgrade was evident at this coverage level. However, the percentage of nonskid compound remaining on the two membrane sheets had been reduced to 36 percent for sheet 1 and to 52 percent for sheet 2. The nonskid compound applied with paint rollers (as described in paragraph 81) to an area of sheet 2 was holding up well. Approximately 80 percent of the solid-coated nonskid compound remained after 200 coverages of the test wheel (photo 87).

Photo 87. General condition of 54-in.-wide run of material that was recoated with nonskid after 200 coverages on test section 2

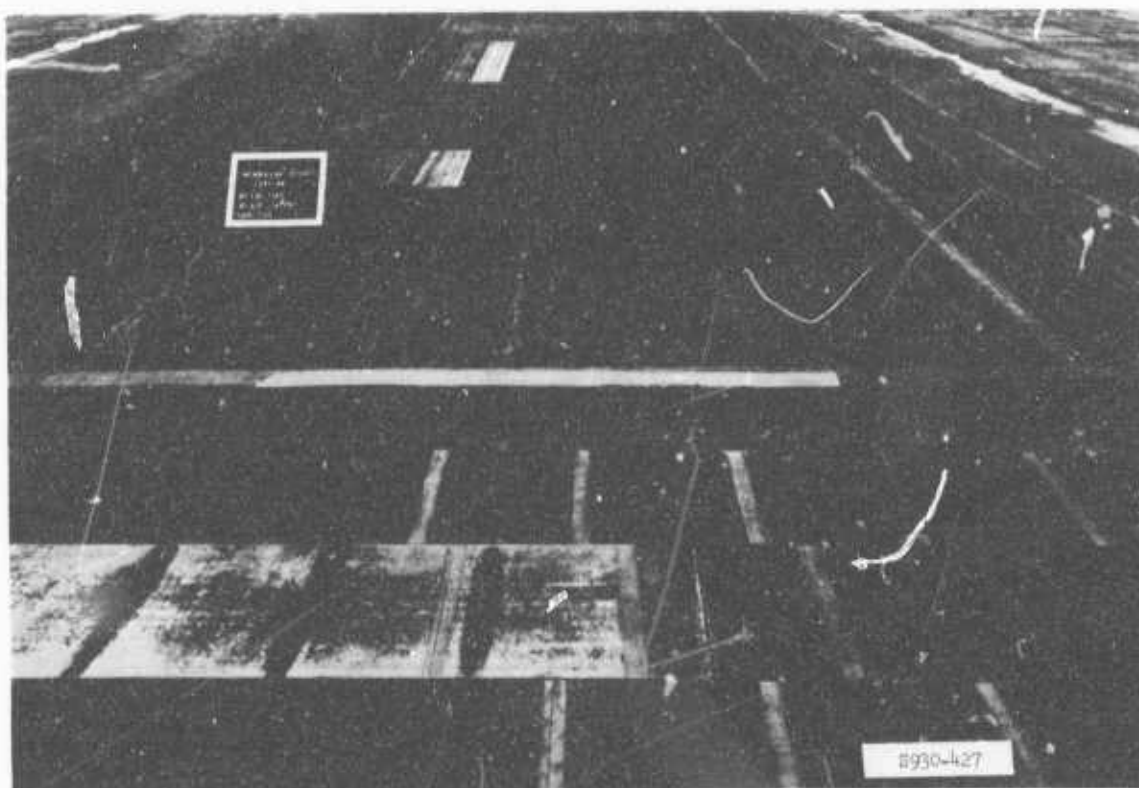
85. A total of 69 percent of the nonskid compound had been worn off by the test wheel on sheet 1, and approximately 66 percent of the nonskid had been lost on sheet 2 after 1000 coverages. The general condition of sheets 1 and 2 after 1000 coverages is shown in photos 88 and 89, respectively.

Photo 88. General condition of sheet 1 of test section 2 after 1000 coverages

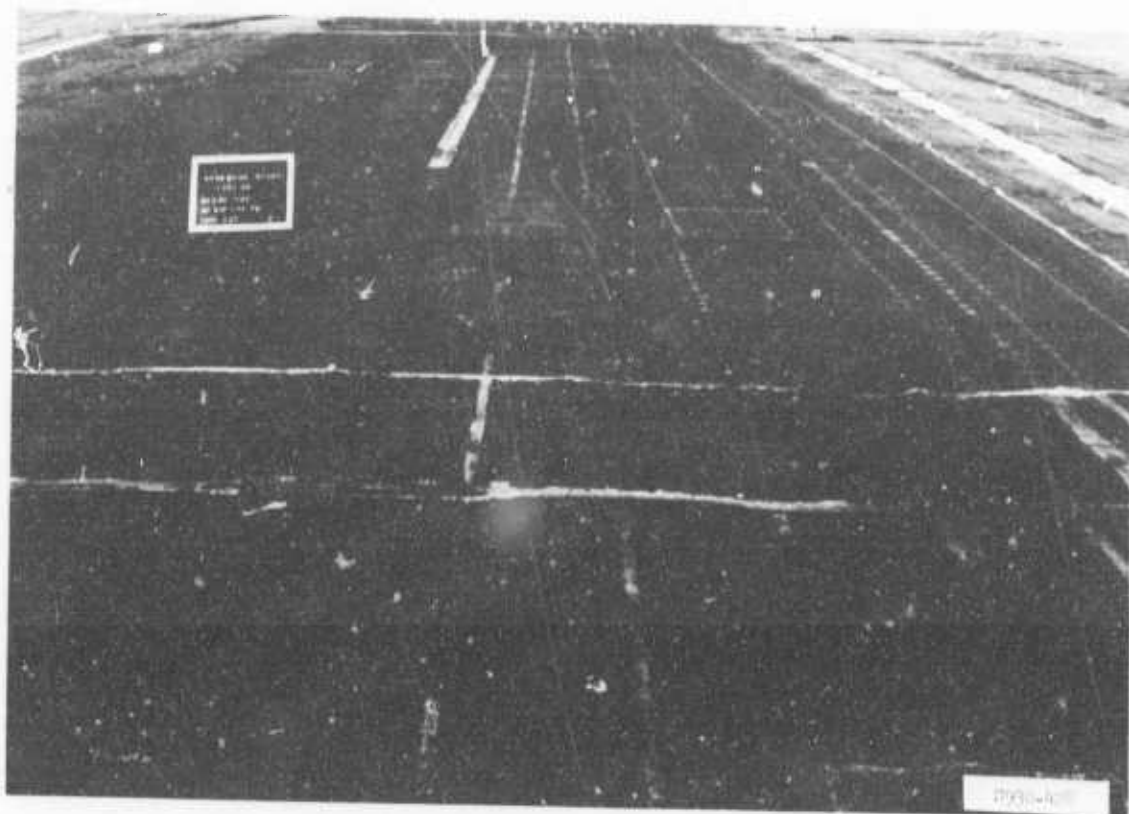
Photo 89. General condition of sheet 2 of test section 2 after 1000 coverages

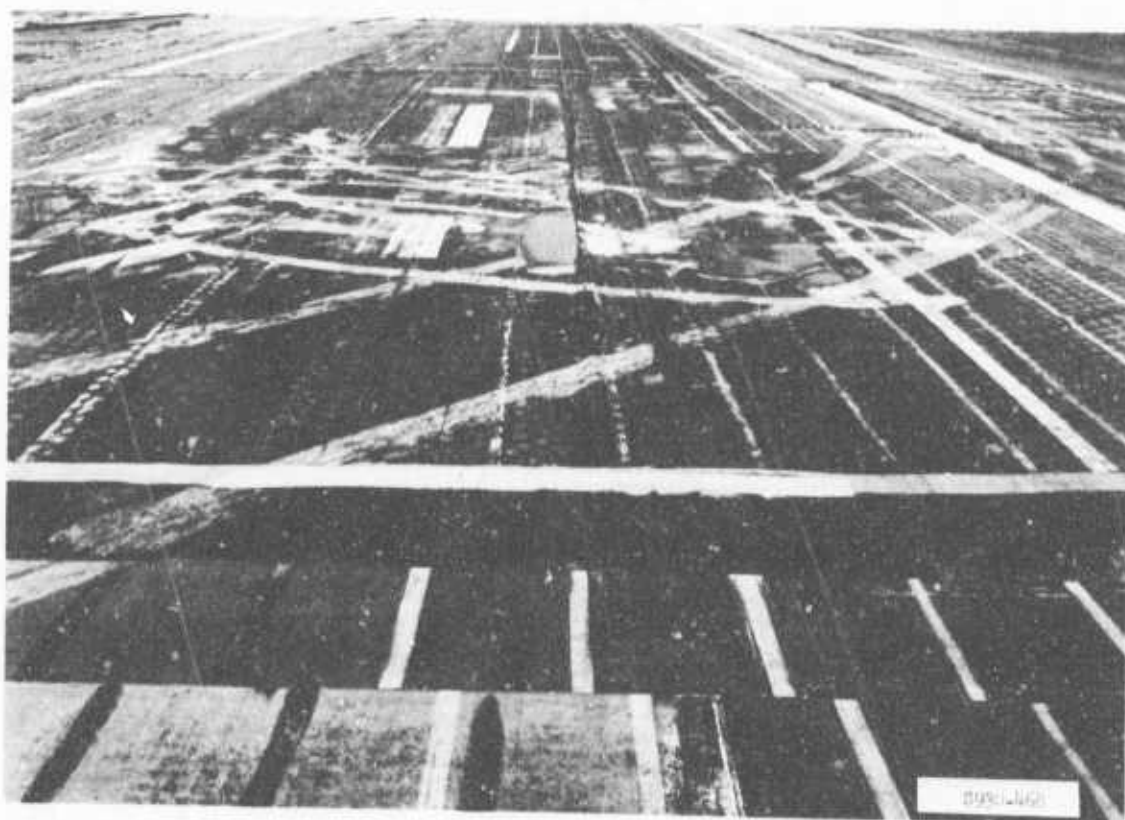
86. An overall view of the test section taken following a heavy rain at 1200 coverages is shown in photo 90. As can be seen by the good drainage of the section, only slight rutting of the subgrade had occurred during trafficking, indicating that the membrane had retained its waterproof seal. (A total of 2.08 in. of rainfall had occurred since the 1000-coverage level.) The good condition of the subgrade was confirmed by cross sections taken at 1200 coverages that indicated only consolidation of the subgrade under the test wheel with no appreciable rutting (plate 20). CBR readings taken at this coverage level indicated a slight increase in soil strength in the area of the traffic lane (table 6).

Photo 90. General condition of test section 2 after 1200 coverages

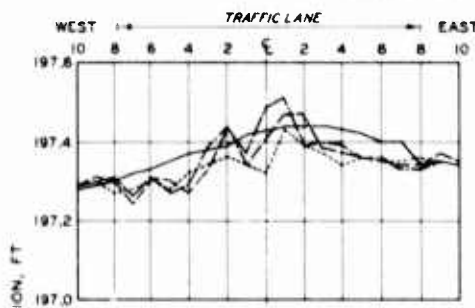
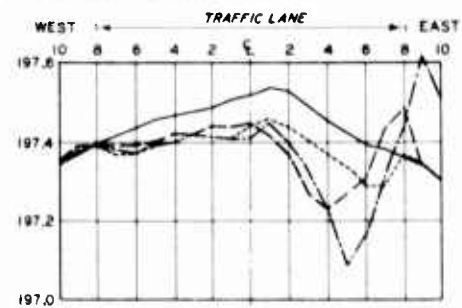
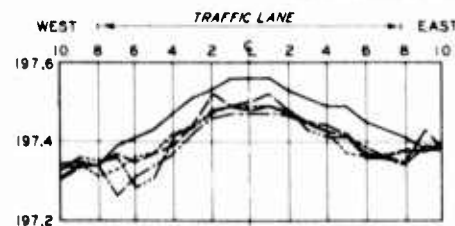
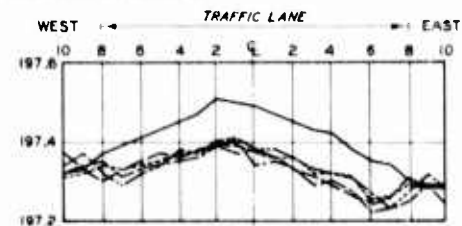
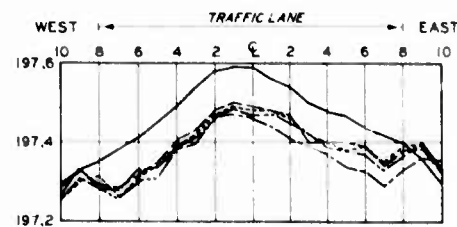
CROSS SECTIONS
 TRAFFIC LANE
 REDESIGNED XW18
 TRAFFIC SECTION 1

RECONSTRUCTION AFTER 538 COVERAGES
